Case 242 : Narrative

Case Vehicle (A): 2000 Dodge	Vehicle (B): 1998 Chevrolet
Type: Caravan, minivan	Type: Cavalier, 2-door coupe
Driver: 29-year-old male	Driver: 53-year-old male
CDC: 12-FLEW-3, 10-LDEW-3	CDC: 99-0000-0, 99-0000-00

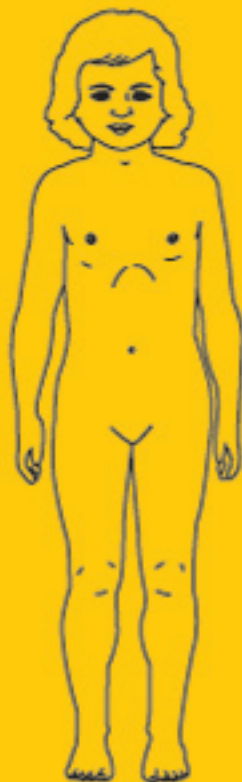
Unknown
if injured

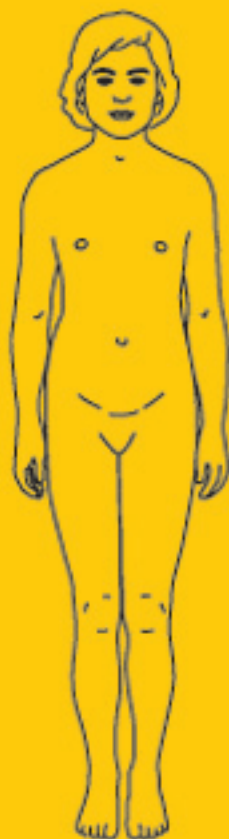
"A" injuries per police;
details unknown
